An Analytic and Experimental Evaluation of the HALO™ Rollover Damage Minimization Device

Stephen A. Batzer, David Beltran, Chandrashekar Thorbole

Abstract

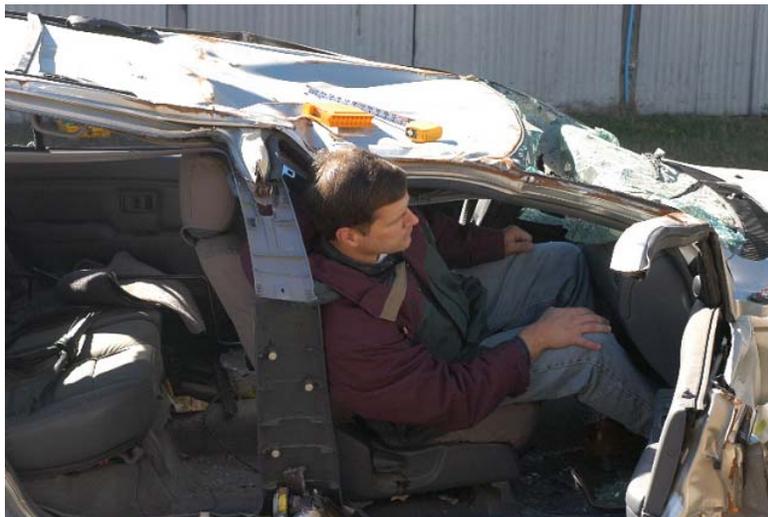
Fig. 1: 2002 Toyota 4Runner post rollover accident, spinal injury incurred at position shown.

During rollovers it is this “breaking of contact” with the ground from the leading roof rail to the trailing roof rail that causes the severe impact. Note that when a tubular canister rolls along the ground, the periphery maintains contact and no abrupt changes in velocity occur. As the vehicle continues to rotate past contact of the leading side roof rail, the vehicle continues to move downward. As the trailing roof rail impacts, its geometry works to force a change in velocity of the center of gravity. If the roof is relatively weak, it will severely deform as did the roof in Figure 1.

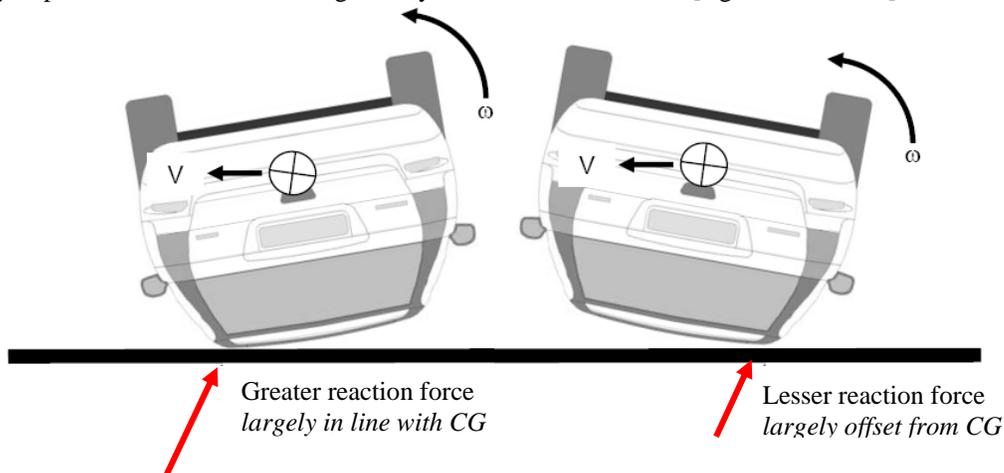
Fig. 2: Barrel rollover mechanics showing idealized ground interaction forces. Vehicle is moving right to left.

Two rollover impacts are disproportionately severe. Figure 2 shows a vehicle traveling from the right to the left. For this overturn, the driver’s side (US Convention) or left side, is called “initially leading” as the vehicle yawed clockwise when viewed from above prior to overturn. This is a pure barrel roll. The roof rail on the left side of the vehicle should impact the ground first with a minor impact. As the vehicle continues to overturn, the center of gravity (CG) of the vehicle continues to accelerate downward. It is the second roof impact on the initially trailing, right hand side, of the vehicle that is severe and leads to significant occupant injury, particularly with belted occupants. This first major impact to the vehicle on the initially trailing side in a barrel rollover produces disproportionate damage if the roof is relatively weak and in fact serves as a roll direction indicator post collision. The second disproportionate impact occurs when a vehicle ends on its roof in conclusion of a multiple roll event. Damage that has accrued during previous roof impacts coupled with the high friction of rolling to a halt can induce a more damage than occurs during the previous higher velocity impacts. This may be counter-intuitive that lower velocity impacts cause increased damage, and yet it is well documented [e.g., Batzer, 2007].

Note that on the first strike of the vehicle shown at right, the force vector of ground loading, which is complex and includes both a normal and shear force, is relatively parallel to the driver’s side A-pillar. This brings about columnar loading for which the member is suited. The loading at the passenger’s side of the vehicle shown at left is not columnar, but cantilever loading. This large moment applied to the pillar can cause large deformation. The engaged columns are usually the A-pillars as vehicles tend to roll nose-down due to engine weight. Further, notice the direction of the applied reaction force vector to the center of gravity. The first impact, shown at right, obviously causes a moment couple as the force vector is significantly “off axis” from the center of gravity. This will cause the vehicle to increase its rotational motion. The second impact, shown at left, has the reaction force vector nearly coincident with the vehicle’s center of gravity. Thus the vehicle is less able to rotate out of the way of the applied force.

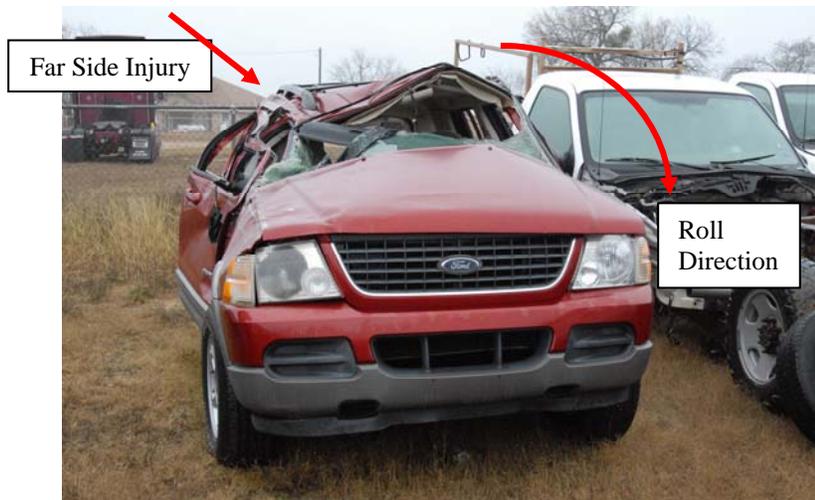
Fig. 3: Results of rollover showing disproportionate damage to initially trailing side. Note that 95% of rollovers are 2 revolutions or less [Hare, 2002].

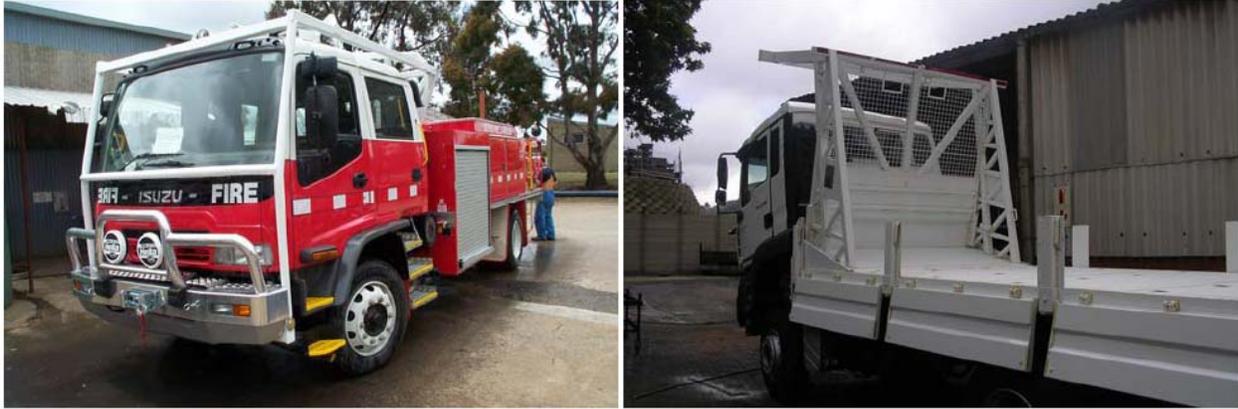
Fig. 4: Two external rollover-protection roof retrofits; original roof structure is unaltered.

Stronger roofs are safer roofs. This is intuitively obvious and not controversial [e.g., Chirwa, 2006; Strashney, 2007; Brumbelow, 2008]. Baccouche [2000] indicated that, “The crush resistance of roof structures is critical to minimizing injuries and enhancing occupant survival during rollover crashes.” Saab, Mercedes-Benz, and Volvo have all touted their strong roofs as a definite safety plus for their customers. In fact, in the early 1970s the marketing arm of Volvo took seven flood damaged model 140 sedans and stacked them to show the roof strength of their vehicles. A review of available technical strategies for building strong, rollover crashworthy roofs was given by Herbst, et al. [Herbst, 1998]. Each of these techniques was for the production vehicle, and include high tensile strength steel, thick stampings, gussets at intersections, closed sections, and structural foam at points of maximum bending moment to prevent buckling. However, the FMVSS 216 standard that vehicles are currently required to meet is so inadequate that the Australian government was recommended to reject it as a national standard by independent engineers [Henderson, 1997]. While it is hoped that the newly upgraded FMVSS 216 will minimize roof crush to an acceptable level, there are many older and even currently produced vehicles that require roof strengthening in order to protect the occupants in rollover. Vehicles without strong roofs are notoriously difficult to retrofit. Two examples of external retrofits are shown in Figure 4, and are obviously sub-optimized systems.

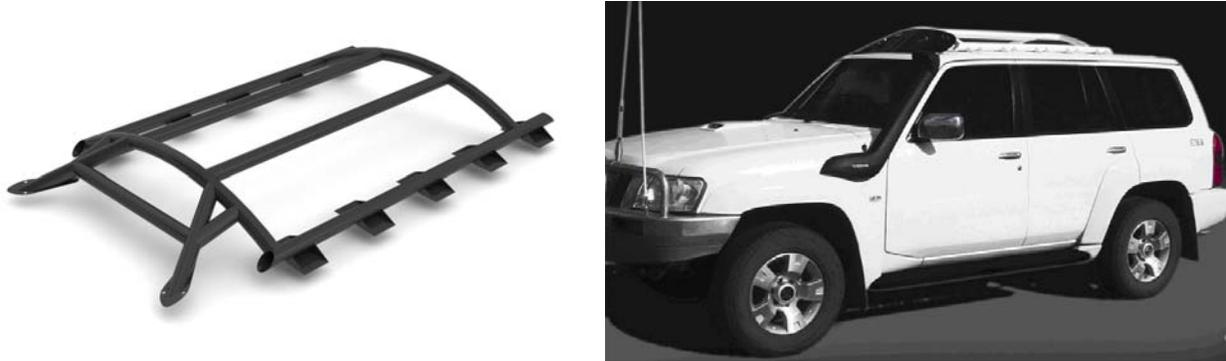
Fig. 5: HALO™ device unattached (L), and affixed to a Nissan Patrol vehicle (R). Note that this vehicle is equipped with a black engine snorkel on the left side.

The HALO™ device uses a convex steel cap which is affixed to the top of the vehicle, similar to the luggage racks that act as decorative trim on many SUVs; it may be removed as required. The principal linear load bearing members are nominal 50 mm (2”) diameter high strength low alloy (HSLA) steel. This material combines good welding characteristics, high ductility/toughness, and strength above that of mild steel. The HALO™ is a single piece of contiguous welded tubing and plates, consisting of external roll bar hoops and longitudinal rails. There are attachment feet and internal B-Pillar reinforcement brackets. Two images of the HALO™ device are shown in Figure 5. Notice the convex shape of the front and rear hoops. This ensures that the major loading tends to be at the center of the hoops, supporting the vehicle’s center of gravity as the vehicle rotates. This diminishes impacts to the trailing (second) side of the roof. If the center of the fore and aft hoops receive loading toward the floor pan of the vehicle, this ensures that all eight pillars of a sport utility vehicle will be engaged. With engagement of more, rather than fewer, pillars, overall roof performance dramatically improves.

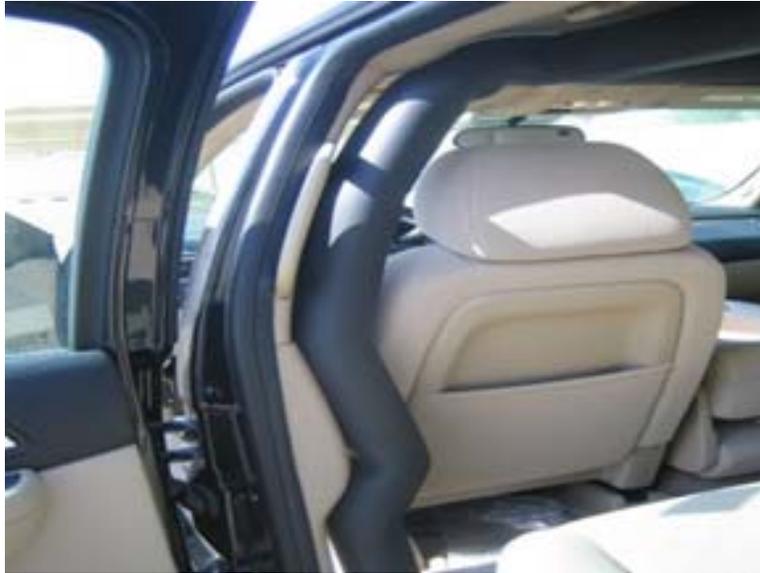
Fig. 6: Internal roll bar system designed to minimize roof crush. Notice size increase due to padding.

RDMDs need to be easily mounted in the field without the need to take the vehicle to a specialty shop. Currently, some RDMDs use internal structures, interfering with the interior volume of the vehicle. This forces the companies to purchase vehicles without side curtain airbags or to disable the airbags which opens them up to legal liability because one aftermarket technology now interferes with or disables another. Figure 6 shows an example internal RDMD which does just that.

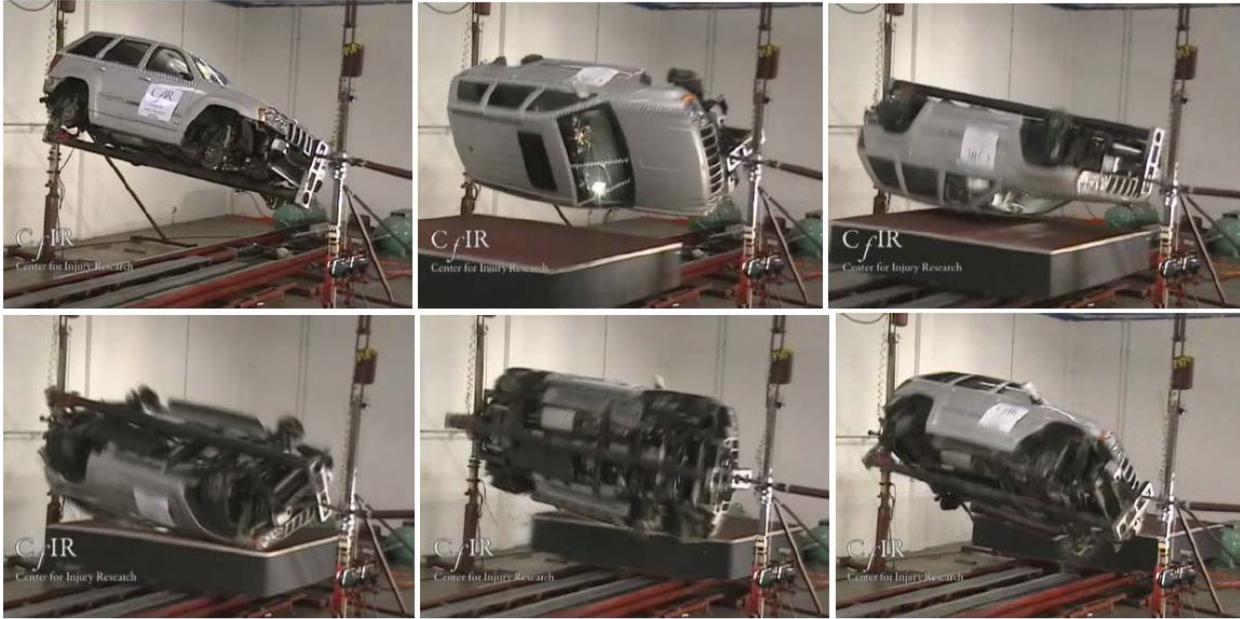
Fig. 7: JRS Test of a 2007 Jeep Grand Cherokee, Roll 1, showing kinematics of the test. Upper right frame shows the initially leading side impact, the lower left frame shows the initially trailing side roof rail impact.

The HALO™ has been validated using a variety of techniques, including simulation, laboratory and dolly rollover. The principal validation has been using the Jordan Rollover System (JRS), see Figure 7. This device uses a balanced cradle to rotate the vehicle which then drops at a known velocity onto a moving "roadway" surface [see Jordan, 2005, Friedman, 2007a,b]. This laboratory fixture allows careful control over input parameters such as vertical impact velocity, pitch angle, and roll angle. The vehicle can be comprehensively instrumented to determine both the residual crush found at the end of the test, but also the peak dynamic crush that occurs while the roof is in contact with the roadway. As the vehicle revolves only once per test, damage can be comprehensively documented as the simulated accident is "frozen" between rolls. The intrusion velocity can also be measured, as opposed to being estimated. Further, by using an instrumented Hybrid-III Anthropomorphic Test Device (ATD), head and neck loads can be directly measured and compared within tests of this type and between tests of other types, such as dolly rollovers.

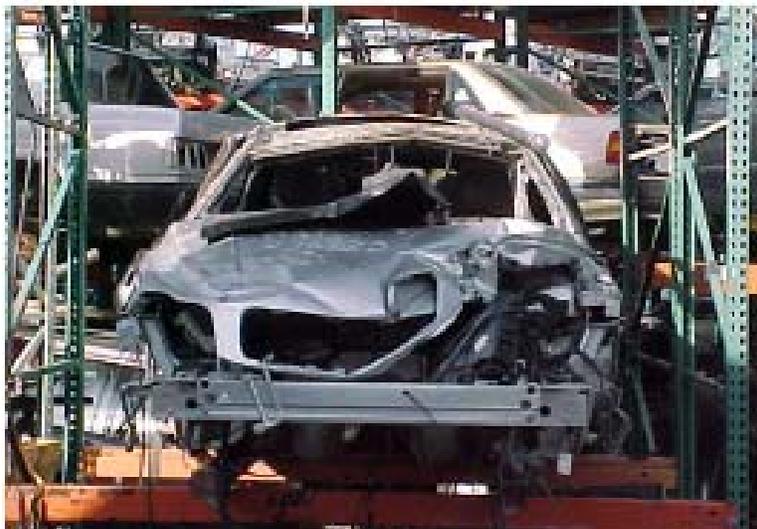
Fig. 8: 2003 Volvo XC90 showing the desirable performance during rollover. The two belted first row occupants were uninjured in the 1.5 roll collision [Hinojosa, 2003]. Roof shows very modest upward tenting of header.

The JRS dynamic rollover tests to validate the HALO™ were conducted by the Center for Injury Research (CFIR) on a 1993 Jeep Grand Cherokee with the HALO™, a production 1993 Jeep Grand Cherokee without the HALO™, and a 2005 Volvo XC90. The unmodified 1993 vehicle was used as a control to determine “stock” performance in a barrel rollover. The XC90 was used as a representative of a very strong production roof. Its strength-to-weight ratio (SWR) as measured by the FMVSS-216 protocol by NHTSA is 4.6 [NHTSA, 2008], and was the strongest production SUV roof at the time of its introduction in the 2003 model year.

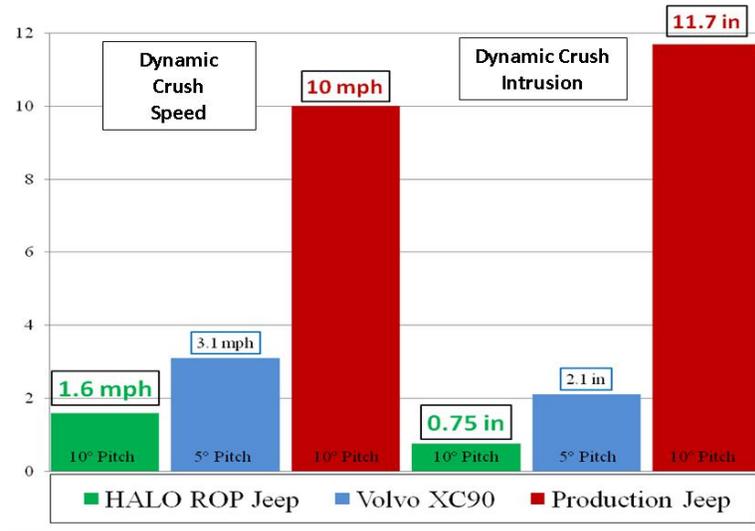
Fig. 9: Dynamic crush speed and intrusion comparison.

Output of the tests included total crush, dynamic crush, dynamic crush speed, and loading to the roadway. Their results show that the increased strength and improved geometry afforded by the HALO™ RDMD ensured that the retrofitted Jeep outperformed the Volvo XC90 and estimated to be about 30% stronger in the rollover crash mode. See Figure 9. It is common to focus on the total crush of a vehicle’s roof crush as an indicator of injury potential (the “nutcracker” mode, trapping the occupant between roof and seat pan), but this is one of two relevant measures. For

occupants whose heads are in contact with the roof, it is the intrusion speed which can produce injuries, regardless of total intrusion.

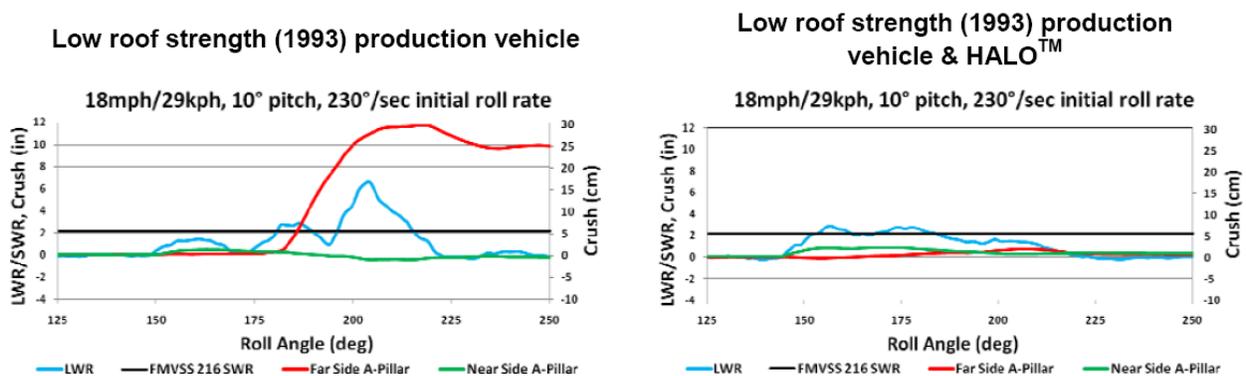
Fig. 10: JRS instrumented roadway surface plots. The dark line represents the vehicles FMVSS 216-measured strength to weight ratio. LWR is a ratio of the load measured by the floor divided by the weight of the vehicle.

In that LWR, SWR and Crush in inches all have similar magnitudes, they share a common axis at the left of each graph.

The instrumented roadway surface from the JRS mechanistically indicates why the device works, see Figure 10. As is known, a dropped object has a certain quantity of kinetic energy at impact, equal to the product of weight by drop height. This is a more or less fixed value. Vehicles must manage their own weights during collisions, and any difference in weight between the three tested vehicles is thus immaterial. However, if the energy can be managed uniformly, rather than piece-meal by corner impact, the peak magnitudes of interaction force can be diminished. The graph at left shows the results for the production vehicle. Notice that the peak intrusion, as shown by the red line, exceeded 10” which represents a high injury potential; typical static headroom is 5”. The green line shows the near side A-pillar, which shows more-or-less no deformation. The blue line shows three spikes of increasing magnitude. The first spike, which starts at about 150 degrees of roll, is minor. It is the engagement of the initially leading side. The next two spikes are actually a single impact, the initially trailing side. Notice how the red line shows far-side A-pillar deformation rapidly, within 10 degrees of roll, with the impact of the trailing side. A peak measured load of approximately six times the vehicles weight is recorded.

The second graph at right is for the same vehicle modified with a HALO™ RDMD. The initially leading side engagement occurs at nearly the same time, but the measured load peaks are “smoothed out.” Since the supporting

hoops are centered on and in a constant radius with the vehicle's center of gravity. The vehicle's roof does not break contact with the roadway as it does with a squared segment. While inverted, the vehicle rolls like a paint canister, rather than a brick. With a more-or-less constant loading of the roof without severe impact shock loading, the roof structure does not show strain localization and damage enhancement. The management of the loading along with the strengthening of the roof ensures that only cosmetic damage is done to the vehicle and the occupant survival space is not compromised.

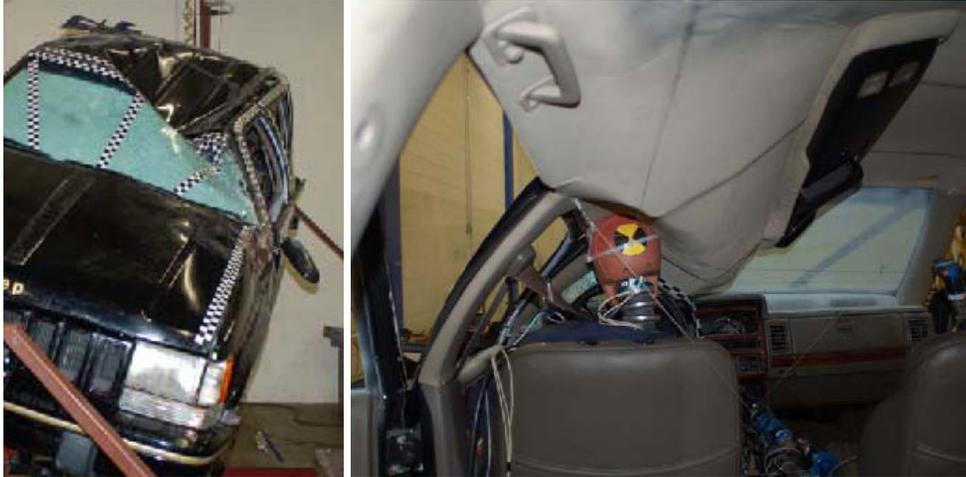
Fig. 11: JRS Test of production 1993 Jeep Grand Cherokee, post roll 1. The objectionable intrusion is obvious and would have caused a life-altering or ending injury. The identical vehicle model run with the HALO™, run twice, had no objectionable intrusion.

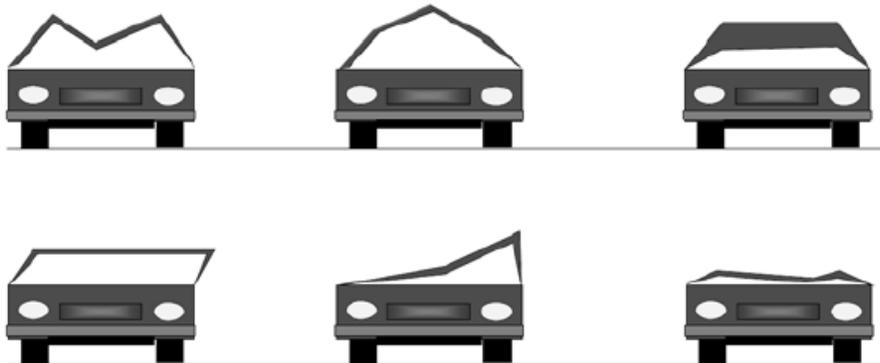
Fig. 12: Schema to describe actual roof deformation pattern as proposed by Friedewald [1994]

A flaw associated with the current US FMVSS-216 test is that it only produces a single damage mode, the inward intrusion of the top of one A-Pillar. As was illustrated by Friedewald [1994], numerous deformation modes are possible and in fact seen after real turnovers. Damage from one roll can act as a failure initiation point and can lead to gross distortion of the cabin.

The “downward V” mode shown at top left of Figure 12 and the “upward tenting” mode as shown at top center are completely eliminated by the application of the HALO™. Further, the increased strength afforded by extra steel, improved geometry that ensures constant roof-to-ground engagement, and increased contiguity that ties the pillars together forcing them to deform in concert, rather than individually, is responsible for the dramatically improved roof performance. As is shown by destructive JRS testing, a roof that performs very poorly in rollover (Figure 11) can be improved with this retrofit device to exceed the performance of a vehicle that is touted as not requiring a roll cage to be safe in rollovers (Figure 8). Both total intrusion and intrusion speed are dropped to levels that, while non-zero, are also non-objectionable.
